## THE BIT WEAR PATTERNS

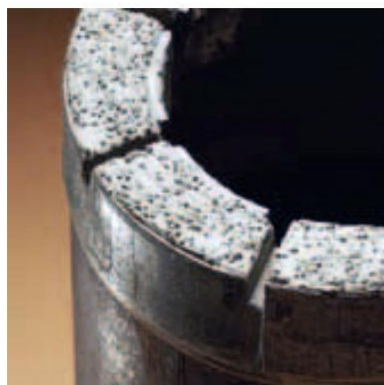
Pattern Example Picture	Pattern Description
 	<p><b>New condition</b></p>
 	<p><b>Ideal wear pattern</b>  The face wear pattern of an impregnated bit should be relatively flat with slightly chamfered sides. Bit feels sharp, comet tails have formed to support diamonds. Diamonds release from matrix as they are worn. Gauge stays within tolerance.</p>
 	<p><b>Normal retirement</b>  Full depth of impregnation evenly consumed. Gauge stays within tolerance.</p>
 	<p><b>Gauge loss OD</b>  Cause:  (A) Lack of circulation – increase coolant flow rate.  (B) Bit being reamed down under-size hole – Check reamer shell gauge and replace if under-sized.  (C) (C) Vibration – alter rpm.</p>

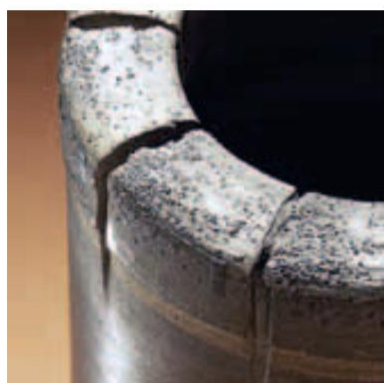
### Excessive diamond exposure

Matrix abrades away before diamonds have worn sufficiently, resulting in high diamond exposure and low bit life. Caused by overfeeding/over drilling – Increase rpi (r/cm), change to a lower series bit or reduce bit weight rpm.

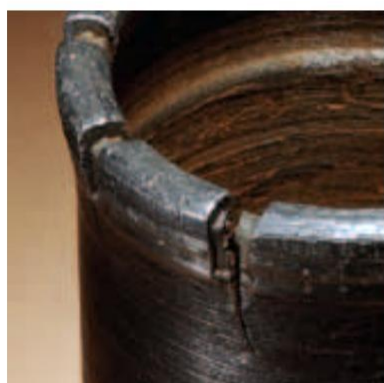
### Face glazed (Diamond polished and metal bound)

Bit does not feel sharp; diamonds flush w matrix; no significant “comet tails” behind each diamond. Sand blast face or use other recommended methods to re-expose diamond. Try again with rpi (r/cm) in the 200/250 (80/100) range. If the face glazes repeatedly, change to a higher bit.

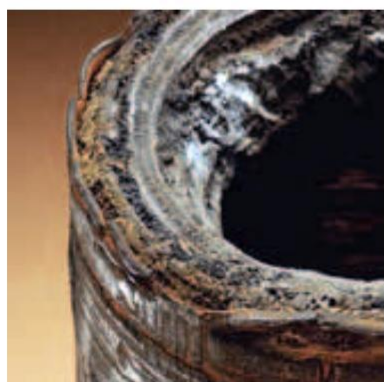
### Cracked waterways(diamonds polished)

- (A) Excessive bit load; dropped rods; free fall of (wireline) inner tube in dry hole;
- (B) bit crushed by rod holder, foot clamp or pipe wrench;
- (C) Pushed down an undersized hole (i.e., reaming shell worn out).
